Dominic Dowling
Faculty of Engineering
University of Technology, Sydney
PO Box 123 Broadway NSW 2007
AUSTRALIA
Ph: 0423 957 389
dominic.m.dowling@uts.edu.au
www.eng.uts.edu.au/~ddowling

July 2006

MODEL HOUSE 4A

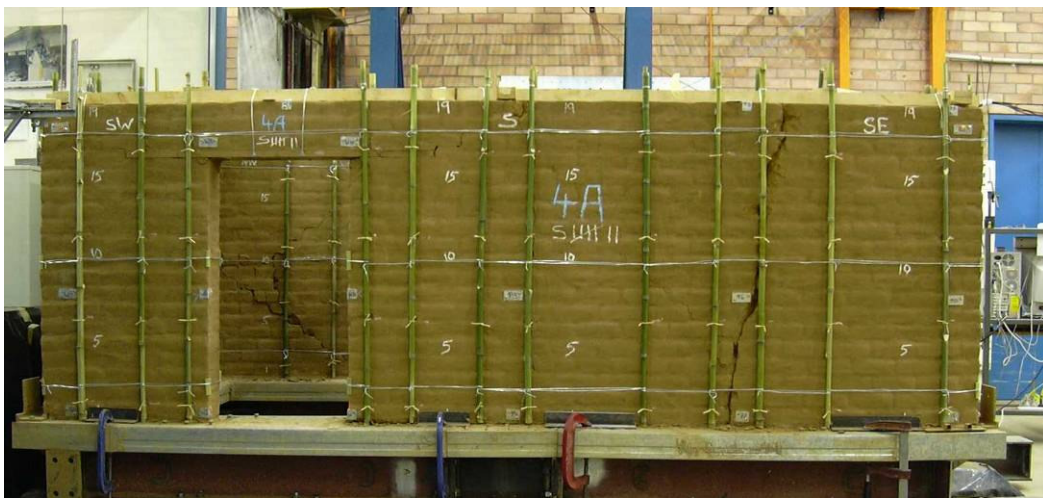
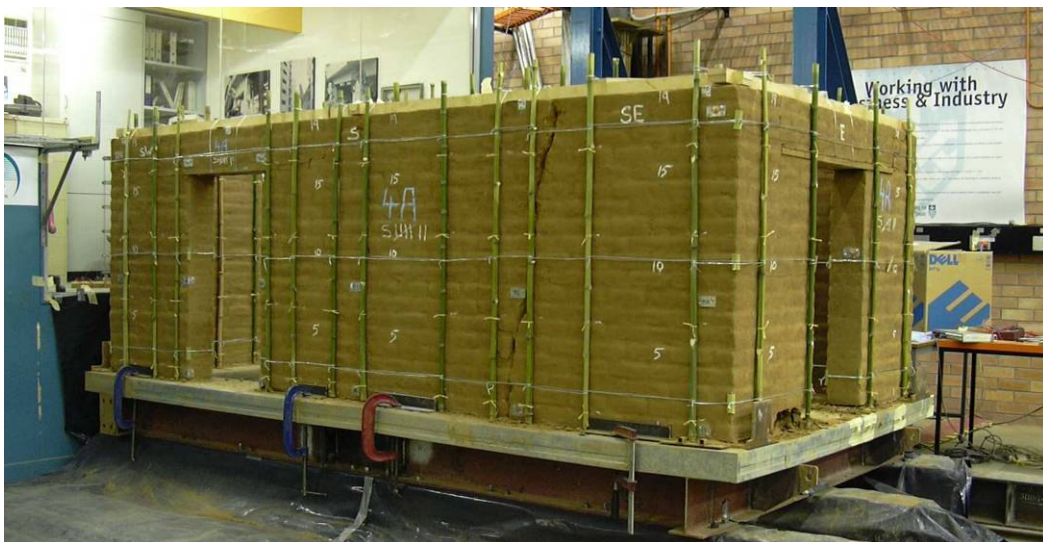
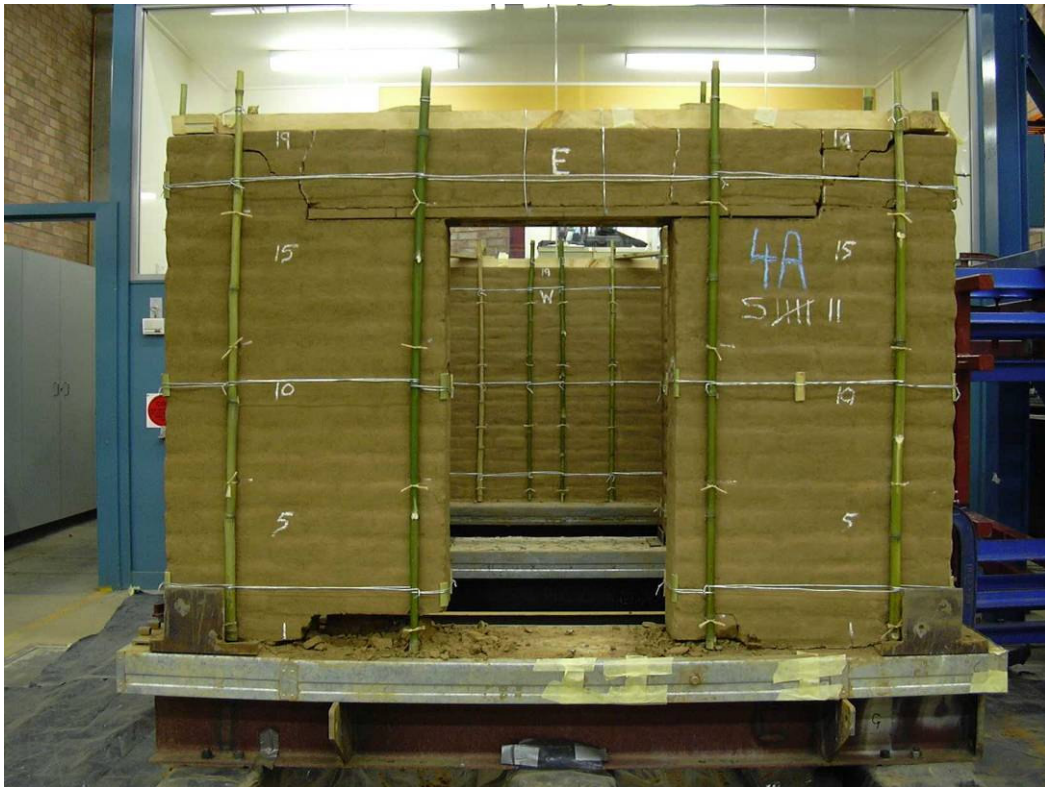
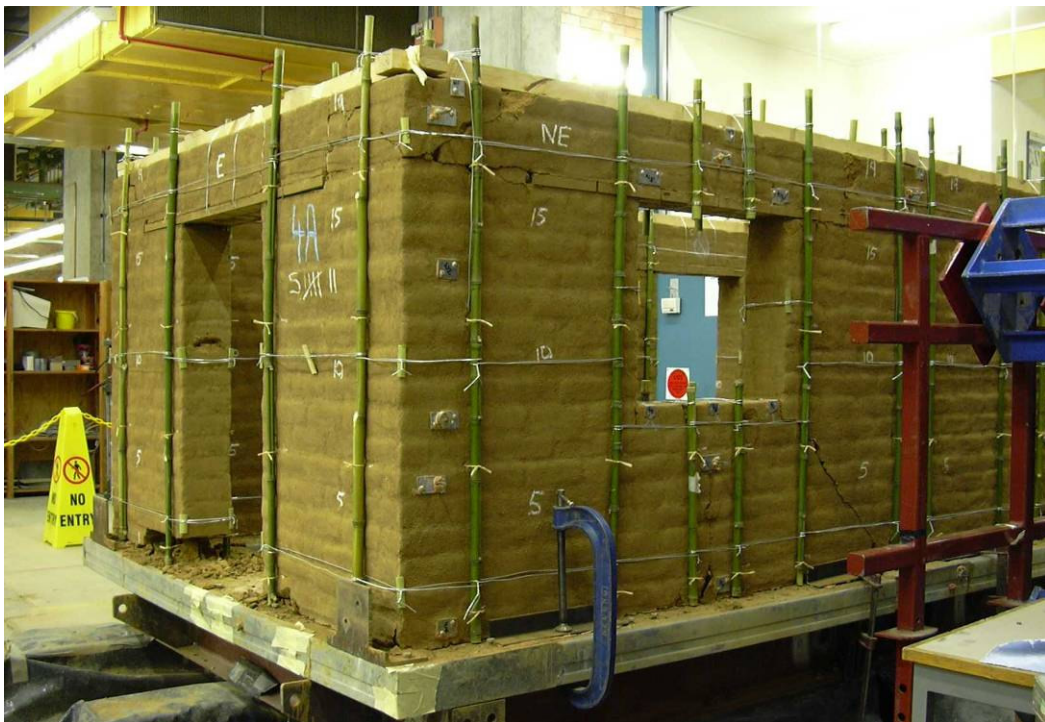
Photos after S7 – 100% intensity (repeated):

S7 – 100% (repeated... progressive damage, but collapse prevented)

[Note: unreinforced u-shaped wall unit totally failed (collapse imminent) during 75% intensity simulation]
