Dynamic testing of unreinforced u-shaped adobe-mudbrick wall unit

B. Samali, D.M. Dowling & J. Li
University of Technology, Sydney, NSW, Australia

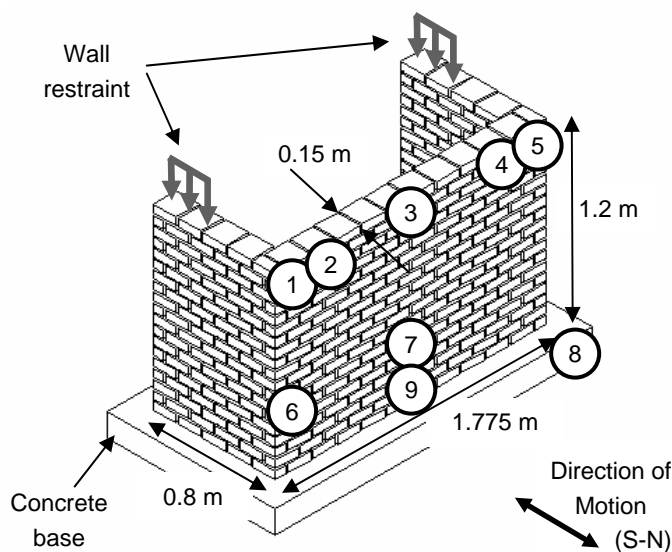
Figure 1. Specimen dimensions and location of LVDT displacement sensors (numbered in circles).

The specimen tested was a u-shaped wall unit, in 1:2 scale. The dimensions of the specimen are shown in Figure 1. These dimensions satisfy the minimum design criteria for unsupported wall length specified in the adobe supplement to the El Salvador building code (RESESCO, 1997). The specimen consisted of 333 full bricks (150 x 150 x 50 mm) and 56 half bricks (150 x 70 x 50 mm) laid in stretcher bond. The mortar was made of the same mud material as the bricks; all mortar joints were 12 - 13 mm thick. The specimen for this first test was unreinforced. The specimen rested on a concrete base, bonded by a mud mortar bed. The concrete base was connected to steel beams and attached to the shake table.

A downward restraining force (Fig. 1) was applied to the tops of the 'wing' walls (acting as in-plane shear walls) to simulate the restraint provided by a continuous wall, and to prevent overturning of the complete unit. This effectively transferred the bulk of the seismic loading to the areas of main interest: the vulnerable out-of-plane long wall, and the corner connections. The restraining force was applied by tension bars between timber platens and beam resting on the walls and the concrete base. A pressure of ~125 kPa was applied, representing 50% of the load which induced initial cracking in a series of compression tests on mudbrick masonry prisms. This applied restraining force is a significant difference between this experiment and other dynamic tests on u-

The locations of the displacement sensors used in the experiment are shown in Figure 1. The anticipated failure pattern was vertical corner cracking, but it was unknown whether this would be due to shear failure (with cracking in the face of the long wall) or tearing failure (with cracking in the face of the 'wing' walls). In order to record the relative movements for both possibilities, five dynamic LVDTs were placed across the long wall, 80 mm below the top of the wall. A further two dynamic LVDTs were placed 350 mm up from the base, and one dynamic LVDT was located on the concrete base to record the reference base displacement. A single static LVDT was positioned at the mid-point and base of the wall to record the relative displacement of the specimen with respect to the concrete base.

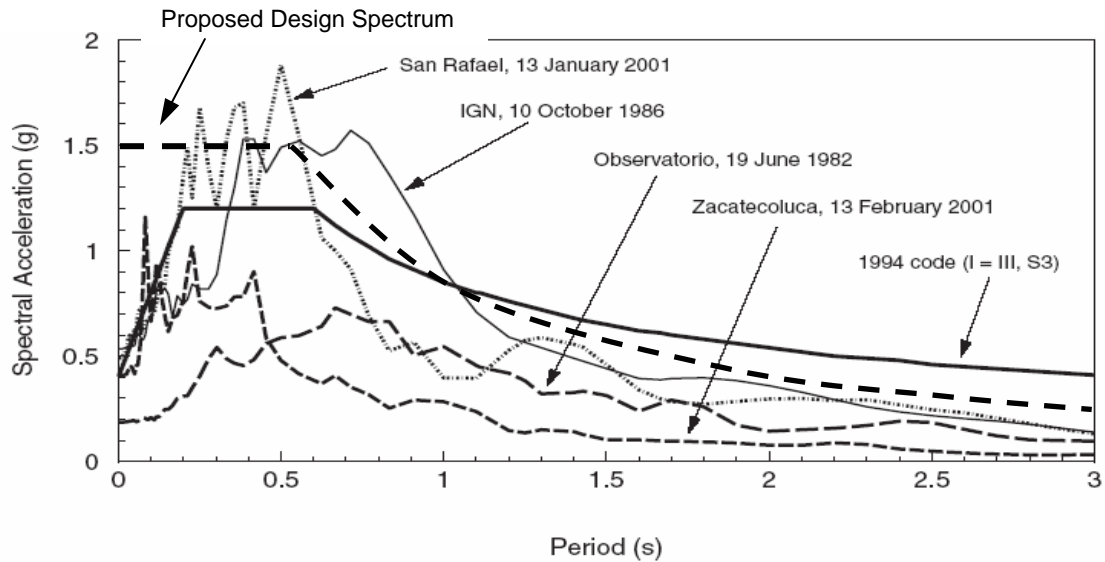
Figure 2. Proposed Design Spectrum (thick dashed line) vs Elastic Response Spectra developed from some El Salvador earthquakes (courtesy of Lopez et al. 2004)

For seismic simulations using a shake table, an appropriate input time history signal is required. Selection and modification of a given input time history is based on the design response spectra recommended by relevant seismic standards. Since adobe structures generally exhibit an elastic response followed by a brittle failure mechanism, the Elastic Response Spectra was used in this study. The proposed design spectrum is a modified version of the El Salvador design spectrum (Fig. 2) reported by López et al (2004). Two modifications have been made to the El Salvador design spectrum as follows:

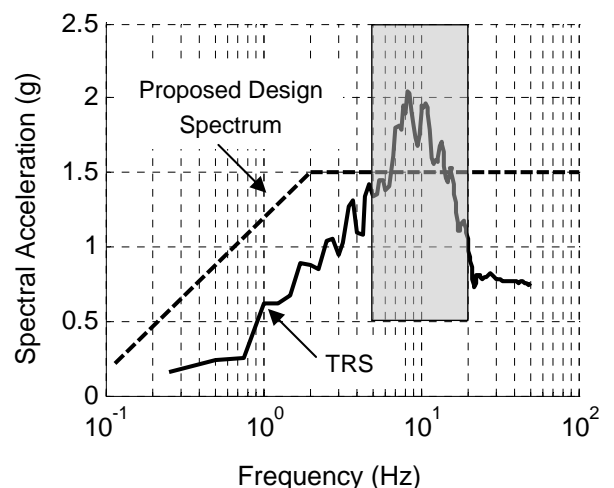
Figure 3. Calculated Test Response Spectrum (TRS) (solid line) in relation to the proposed design spectrum (dashed line). The shaded section is shown in Fig. 5.

Once a suitable design spectrum has been chosen, the selection of an appropriate input time history can commence. The selection process includes calculating the Test Response Spectrum (TRS) for a given input time history and plotting it against the proposed design spectrum. Past earthquake re-

ords or artificially generated synthetic earthquakes can be used as the input time history. In this study, the input time history from the M_w 7.7 January 13, 2001 El Salvador earthquake was used. (This earthquake, in combination with a M_w 6.6 earthquake on February 13, 2001 in the same area, caused the destruction of over 110,000 adobe houses (DIGESTYC, 2001; Dowling, 2004a)). If the calculated TRS envelops the portion of the proposed design spectrum in the frequency range of interest, that particular input time history can be selected as the input signal for the shake table testing. Figure 3 shows the TRS vs the proposed design spectrum, in relation to frequency. It is only necessary that the proposed design spectrum be enveloped in the high frequency resonant range, which is typical of adobe wall units.

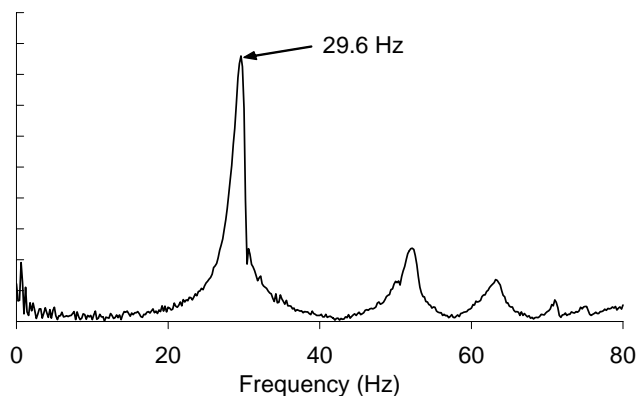
Figure 4. Frequency Response Function (FRF) of the specimen from the modal hammer tests.

By means of modal analysis, the Frequency Response Function (FRF) of the scaled specimen was identified (Fig. 4), with the first resonant frequency (natural frequency) of around 29.6 Hz.

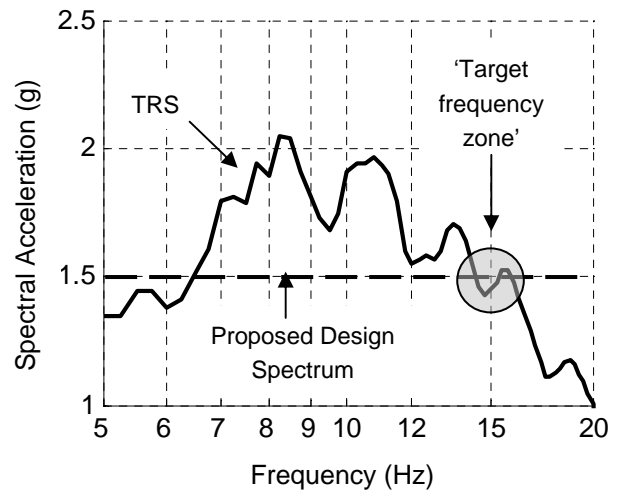
Figure 5. Test Response Spectrum (TRS) (solid line) in relation to the target maximum acceleration (1.5g)

Figure 5 shows the shaded section from Figure 3 and focuses on the frequency range of the Test Response Spectrum (TRS) in relation to the target maximum acceleration response of 1.5g (obtained from the proposed design spectrum). This figure reveals the dominant frequency range of the input spectrum (TRS) to be approximately 6.7 – 15.9 Hz. In order to assess the performance of the mudbrick specimens with respect to the proposed design spectrum (1.5g in the bandwidth of interest) a ‘target frequency zone’ (shaded circle) was identified. Given that the natural frequency of the specimen was 29.6 Hz, a scaling factor between 2.07 (29.6 Hz / 14.3 Hz) and 1.86 (29.6 Hz / 15.9 Hz) was necessary for proper dynamic similitude at the target acceleration. For simplicity, a scaling factor of 2.0 was applied in this case. The scaled input time history is shown in Figures 6 and 7.

The ‘target frequency zone’ between 14.3 and 15.9 Hz was selected in preference to the other option of 6.7 Hz which would have required a scaling factor of 4.4 (29.6 Hz / 6.7 Hz). Such a large scaling factor would have produced a very, very fast earthquake, with very small displacement and very high acceleration.

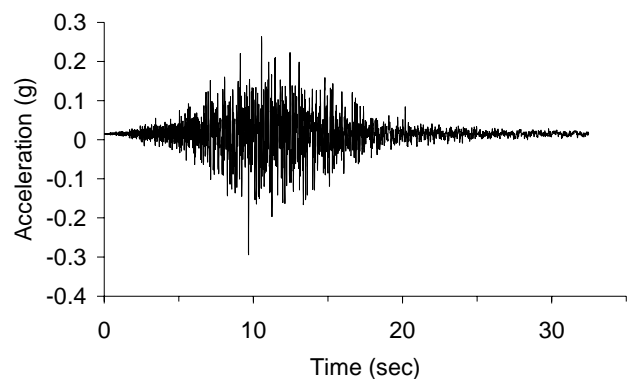
Figure 6. The scaled input time history (full)

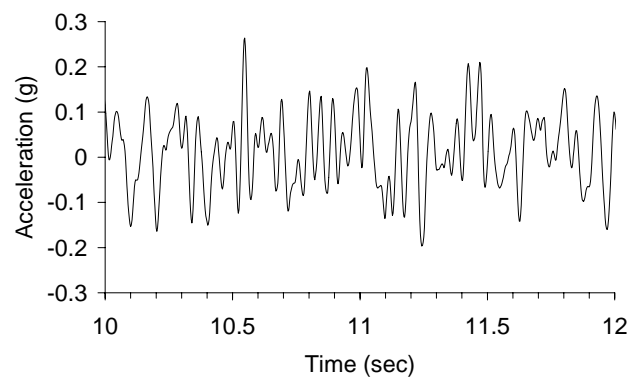
Figure 7. The scaled input time history (t = 10 to 12 sec)

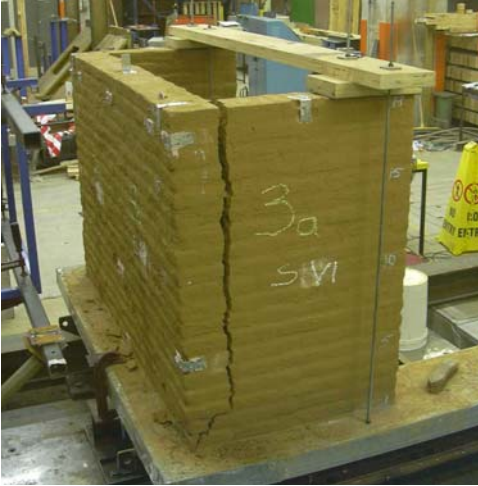
Figure 8. Large vertical crack in NW corner.

The specimen exhibited four distinct and classic failure patterns. The initial and main failure was a large vertical crack in the NW corner, due to the large relative displacement between the in-plane shear ‘wing’ wall and the out-of-plane ‘long’ wall (Fig. 8). The crack was induced by tearing failure of both the mortar-brick interface and the individual brick units. The crack extended from the top of the wall to the base, with a maximum crack width of ~59 mm recorded during the experiment.

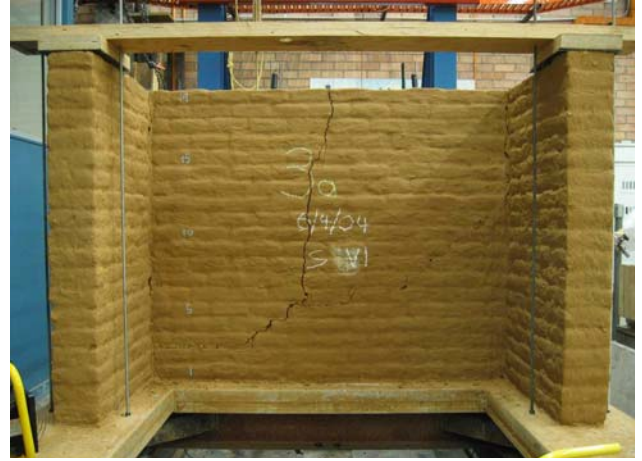
Figure 9. Internal view of wall unit showing stair-step and vertical cracking.

Another crack occurred in the NE corner, resulting from a similar failure mode (tearing failure between orthogonal walls). This crack did not propagate to the base of the wall, but linked with stair-step cracking in the ‘long’ wall (Fig. 9). This stair-step cracking can be attributed to the overturning of the ‘long’ wall, which was induced by the lack of connection with the western ‘wing’ wall, a result of the aforementioned vertical corner cracking.

The other crack was a vertical crack at the mid-span of the ‘long’ wall, which extended from the top of the wall to the intersection with the stair-step cracking (Fig. 9). It can be surmised that this crack was formed in a two-step process, consisting of a weakening stage and a failure stage.

After the failure of the corner connection between the ‘long’ wall and the western ‘wing’ wall, the wall panel experienced an overturning moment, with components about both the vertical and horizontal axes (out-of-plane). It seems reasonable to suggest that the moment generated about the vertical axis acted on the previously weakened vertical mid-span plane to cause cracking, with the width of crack larger at the internal face (splitting) than the external face (crushing) of the wall.

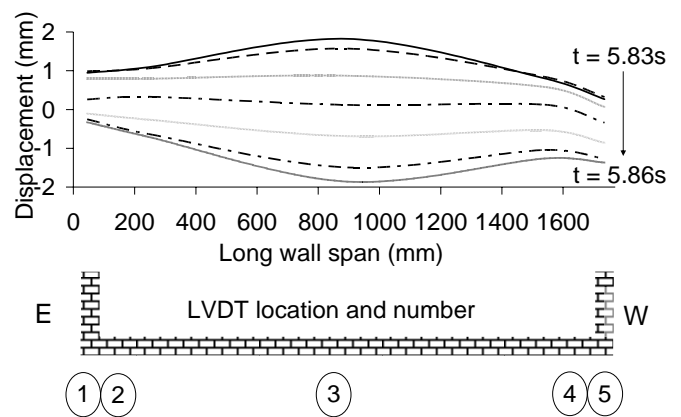
Figure 10. Flexural displacement of ‘long’ wall from $t = 5.83\text{s}$ to $t = 5.86\text{s}$ (prior to initial significant cracking)

Firstly, the flexure induced in the ‘long’ wall (prior to any vertical corner cracking) would have generated a splitting-crushing cycle at the mid-span section of the wall. Figure 10 shows the flexural displacement in the ‘long’ wall prior to formation of the first significant cracks in the specimen. Although both the recorded displacement data and the video footage fail to indicate whether notable cracking occurred at this location prior to the formation of the other cracks described above, it is clear that this process weakened the structure along this vertical plane, making it susceptible to damage by a secondary means.

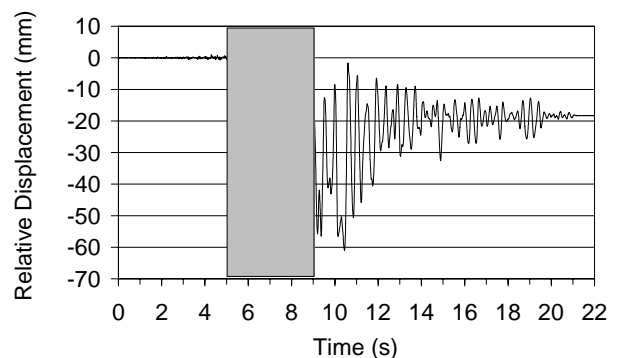
Figure 11. Displacement-time history for LVDT 5. (Shaded section is shown in Figure 12.)

The displacement-time history for LVDT 5 (western side of the ‘long’ wall) is shown in Figure 11. The time history graph shows the loss of stiffness of the specimen (an indication of major cracking) at $t \sim 6.2\text{s}$ and the significant offset of the sensor, with the post-failure neutral point $\sim 19\text{ mm}$ from the original (displacement = 0). The asymmetry of the specimen after failure is represented in the graph, with the largest displacements (negative displacements) occurring for wall motion outwards, and the ‘wing’ walls preventing large displacements inwards (positive displacement).

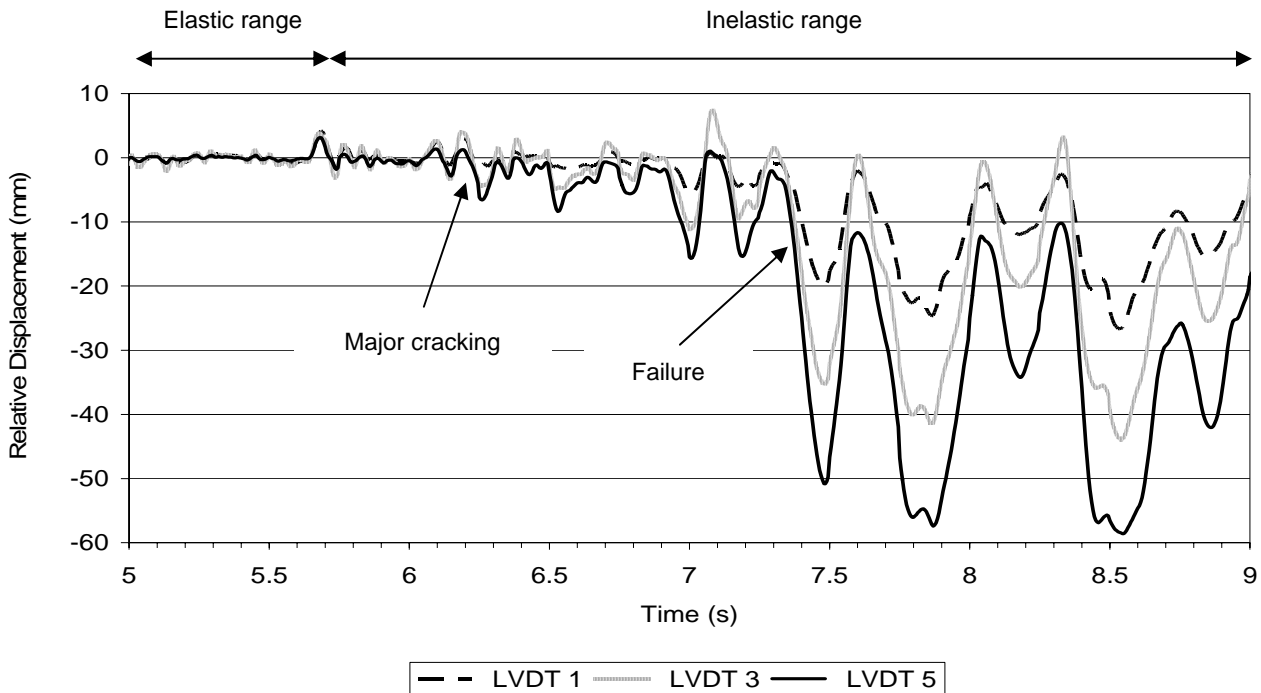
Figure 12. Displacement-time history for LVDTs 1, 3 and 5 (for $t = 5\text{ s}$ to $t = 9\text{ s}$).

Figure 12 shows an enlarged section of the time history. For the western section of the 'long' wall (recorded by LVDT 5) the elastic uncracked response is up to $t = \sim 5.7\text{ s}$, because the original neutral point (displacement = 0) is maintained. From $t = \sim 5.7\text{ s}$ the response can be considered inelastic (cracked phase). It is supposed that the initial cracking at the NW corner commenced at $t = \sim 6.2\text{ s}$, and failure of the corner occurred at $t = \sim 7.3\text{ s}$.
