AN IMPROVED MEANS OF REINFORCING ADOBE WALLS - EXTERNAL VERTICAL REINFORCEMENT

ABSTRACT

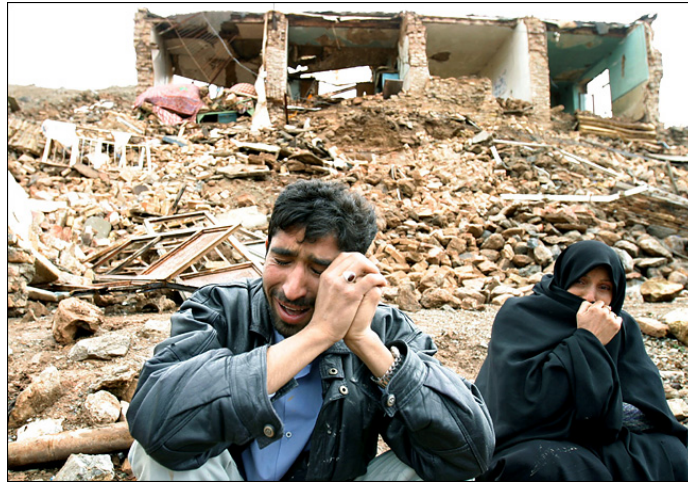
Figure 1. Earthquake impact in Iran, February 22, 2005. The Mw 6.4 earthquake destroyed thousands of adobe homes and caused over 500 fatalities (Homavandi /Reuters).

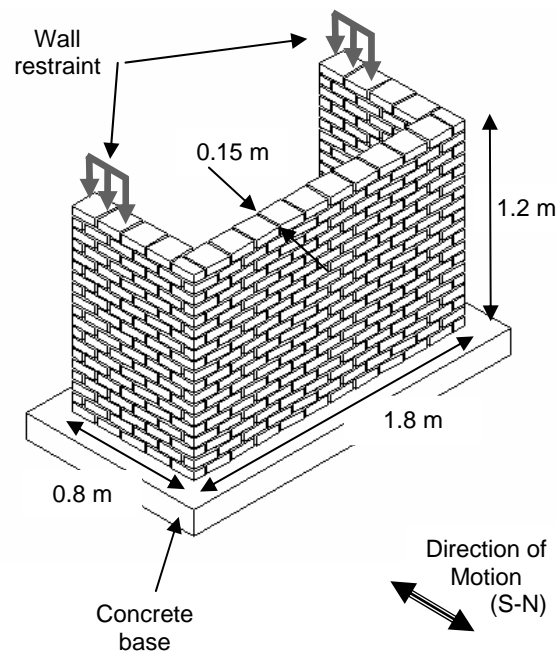
Figure 2. Specimen configuration and dimensions.

The specimens tested were u-shaped adobe wall units, in 1:2 scale, as shown in Figure 2. Specimen dimensions and configuration satisfy design criteria recommended in relevant guidelines (e.g. IAEE, 1986; RESESCO, 1997). Each specimen consisted of 333 full bricks (150 x 150 x 50 mm) and 56 half bricks (150 x 70 x 50 mm) laid in stretcher bond. Bricks were dipped in water prior to laying. The mortar was made of the same mud material as the bricks; all mortar joints were 12 - 13 mm thick. A downward restraining force was applied to the tops of the 'wing' walls (acting as in-plane shear walls) to simulate the restraint provided by a continuous wall, and to prevent over-turning of the complete unit. This effectively transfers the bulk of the seismic loading to the areas of main interest: the vulnerable out-of-plane long wall, and the corner connections. The restraining force was applied by tension bars between timber platens and beam resting on the walls, and the concrete base. A pressure of ~125 kPa was applied, representing 50% of the load which induced initial cracking in a series of compression tests on mudbrick masonry prisms. This applied restraining force is a significant difference between this experiment and other dynamic tests on u-shaped adobe wall panels, which do not include any 'wing' wall restraint (e.g. Zegarra *et al.*, 1997) and thus neglect the contribution of the shear walls in the dynamic response of the system.

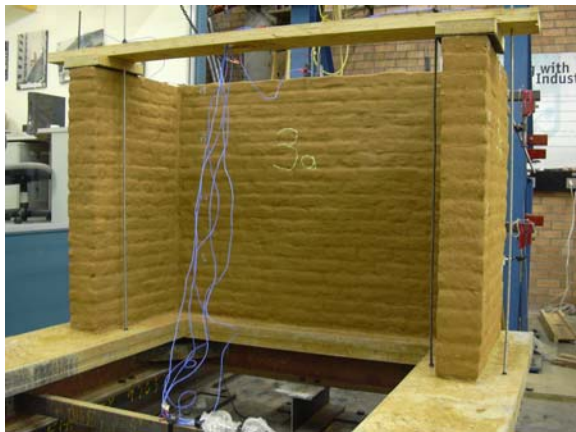
Figure 3. Specimen 3A ready for testing.

Specimen 3A was built to represent an unreinforced, traditional form of construction (Figure 3).

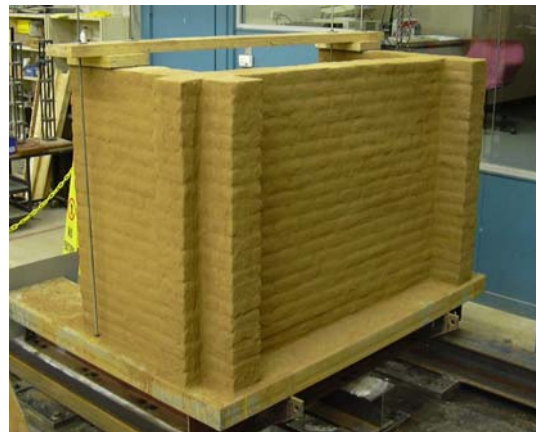
Figure 4. Specimen 3B ready for testing.

The only alteration in Specimen 3B was the addition of corner pilasters / buttresses (Figure 4). The pilasters were fully integrated with the wall via stretcher bond, with pilaster length = width of wall + one mortar joint (ie. ~162 mm representing ~325 mm in full-size).

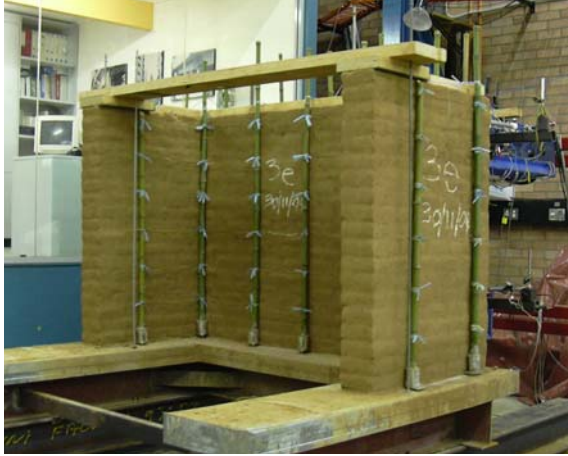
Figure 5a. Specimen 3E ready for testing. Note external vertical bamboo (inside and outside).

Specimen 3E was reinforced with external vertical bamboo reinforcement, internal horizontal chicken wire mesh and a timber ring beam (Figure 5a). Polypropylene strings were weaved through the horizontal chicken wire mesh (perpendicular to the wall). The mesh was then laid in the mortar joints every three courses during construction. 2 mm wire loops to tie down the

timber ring beam were laid in the mortar joint four courses below the top of the wall, at 150 mm spacing. After construction and curing of the wall the vertical bamboo was firmly connected to the concrete support base and attached to the wall (via the polypropylene string). The timber ring beam was connected to the top course of adobe bricks via pins (resisting shear forces) and the 2mm wire loops (resisting uplifting forces), as well as securely attached to the external bamboo by 2mm wire and staples (Figure 5b). The resulting structure was an integrated matrix, with strong connection between the foundation, structure and reinforcement.

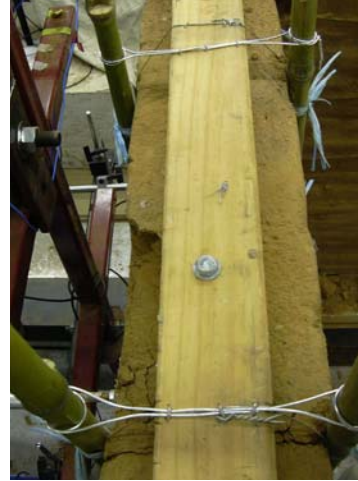
Figure 5b. Connection of ring beam, wall and bamboo (Specimen 3E).

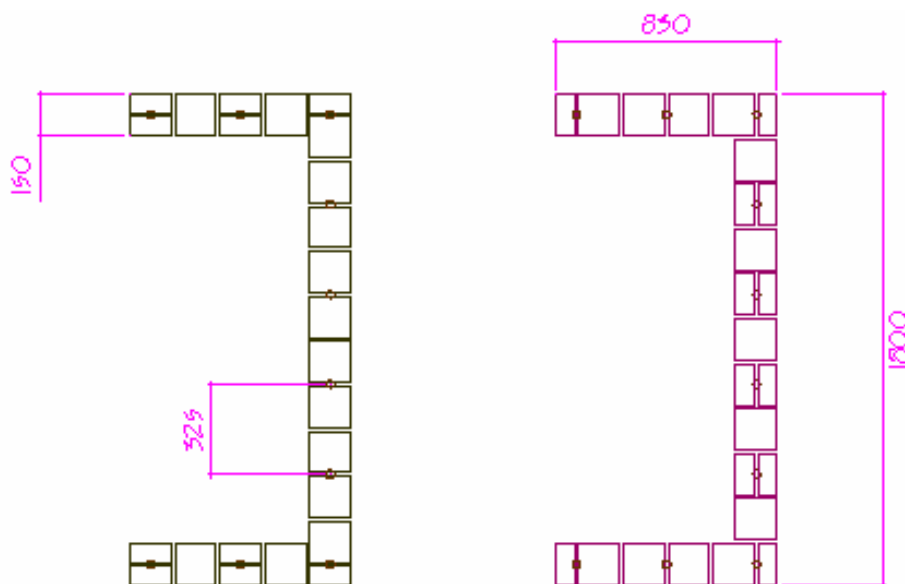
Figure 6. Plan layout for Specimen 3G

Specimen 3G was reinforced with internal vertical bamboo reinforcement, internal horizontal chicken wire mesh (every three courses), and a timber ring beam. The bamboo was securely attached to the foundation prior to construction, and half bricks and full bricks with notches were configured to encase the bamboo at alternate courses (Figure 6).

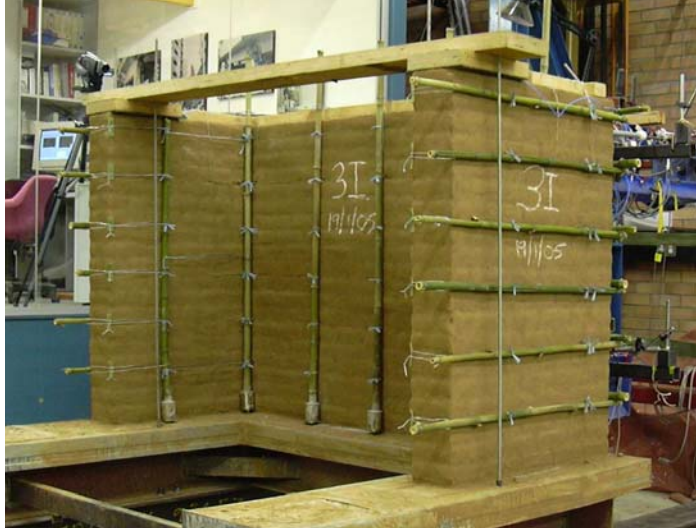
Figure 7a. Specimen 3I ready for testing. Note external horizontal bamboo (outside) and external vertical bamboo (inside).

Specimen 3I was constructed in a similar manner to specimen 3E, except that on the outside face of the structure, horizontal bamboo reinforcement was used instead of vertical bamboo reinforcement (Figure 7a). The horizontal bamboo was securely connected at the corners by drilling the bamboo and inserting small wire pins (Figure 7b).

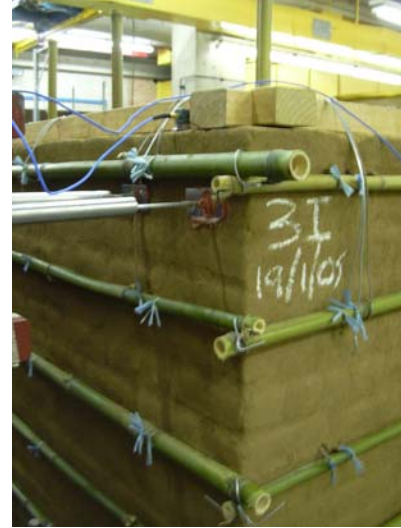
Figure 7b. Connection of external horizontal bamboo at corner (Specimen 3I).

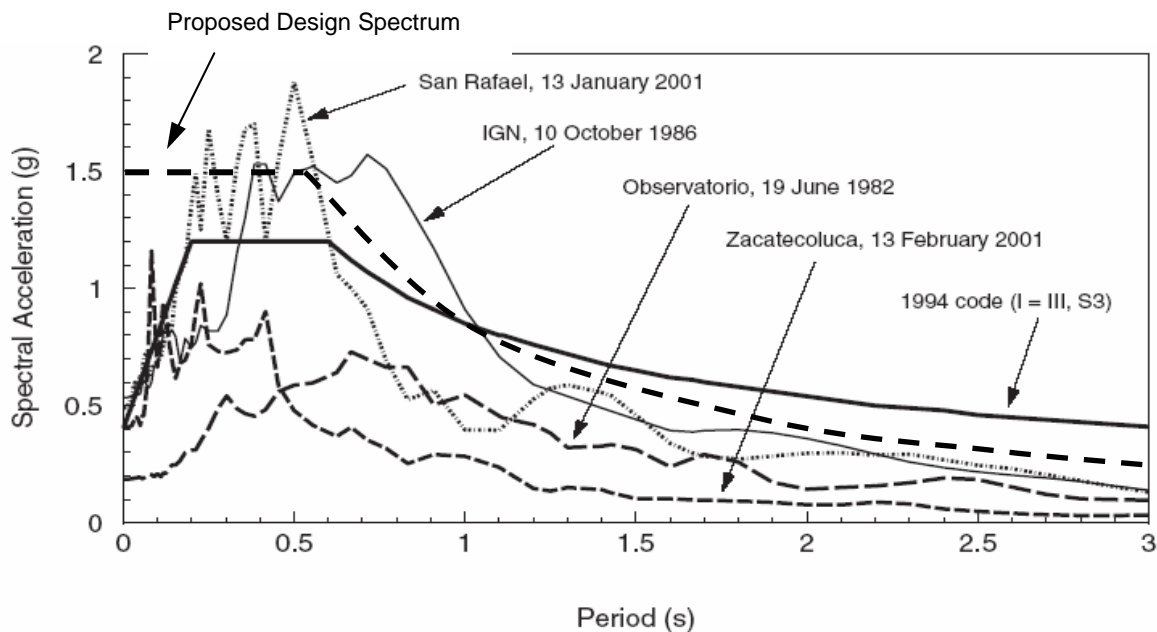
Figure 8. Proposed Design Spectrum (thick dashed line) vs Elastic Response Spectra developed from some El Salvador earthquakes (courtesy of Lopez *et al.* 2004)

The proposed design spectrum is a modified version of the El Salvador design spectrum (Figure 8) reported by López *et al.* (2004). Modifications were made to better envelope recent and more severe earthquakes (elevation of peak spectral acceleration level to 1.5g) and to cover a wider range of frequency contents (extension of the flat portion of the spectrum to a period of 0 seconds), which is considered to be a conservative approach for very stiff structures (such as adobe and other masonry). Since adobe structures generally exhibit an elastic response followed by a brittle failure mechanism, the Elastic Response Spectra was used in this study.

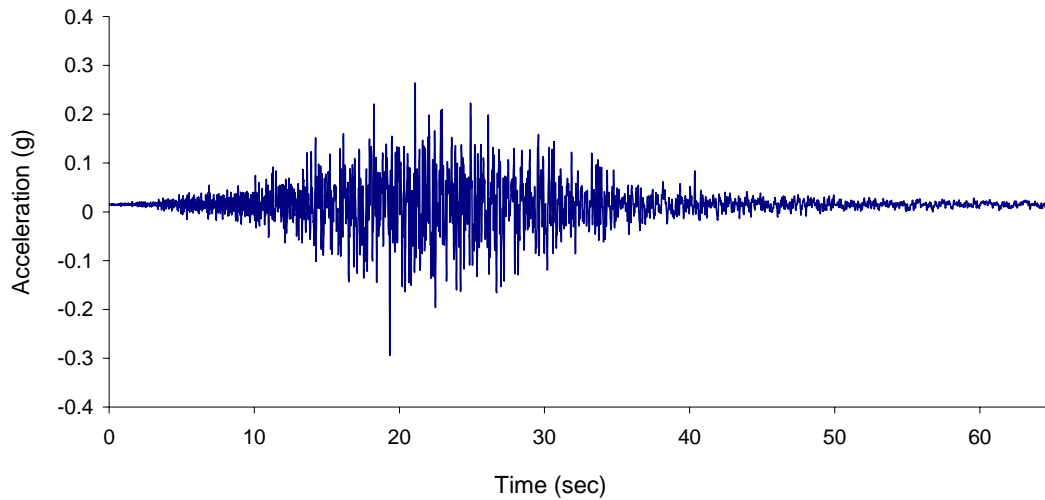
Figure 9. Unscaled input time history (full), January 13, 2001 El Salvador earthquake (UCA Station, Zacatecoluca).

In this study the input time history from the January 13, 2001 El Salvador earthquake (M_w 7.7) was used (Figure 9). (This earthquake, in combination with a M_w 6.6 earthquake on February 13, 2001 in the same area, caused the destruction of over 110,000 adobe houses (DIGESTYC, 2001; Dowling, 2004b)). The Test Response Spectrum (TRS) for the January 13, 2001 earthquake was plotted against the proposed design spectrum (Figure 10a), and found to envelope the portion of the proposed design spectrum (above the design acceleration of 1.5g) in the high frequency resonant range (6.5 -16 Hz) which is typical of adobe masonry. Figure 10b shows the Test Response Spectrum (TRS) in relation to the proposed design spectrum in this dominant frequency range. In order to assess the performance of the mudbrick specimens with respect to the proposed design spectrum (1.5g in the bandwidth of interest) a ‘target frequency zone’ (shaded circle) was identified.

Table 4 shows the observations at each testing stage. The first three simulations used the unscaled (time) input (Figure 9), with increasing displacement intensity: 40%, 100% and 200%. In each case (except 3G) this resulted in no damage to the structures (even at twice the original intensity) and confirms the necessity to use time-scaled input spectra to induce damaging resonance conditions.

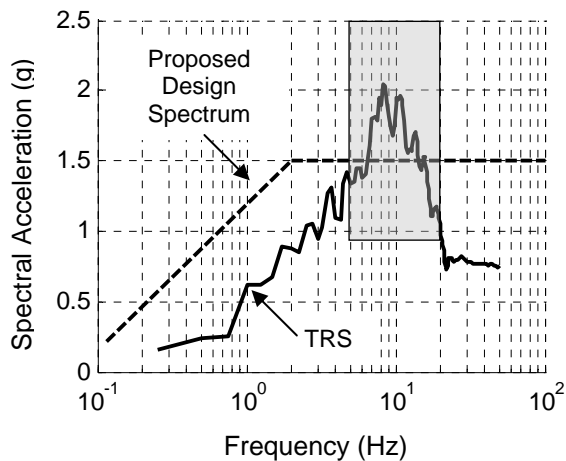
Figure 10a. Calculated Test Response Spectrum (TRS) (solid line) in relation to the proposed design spectrum (dashed line). The shaded section is shown in Fig. 10b.

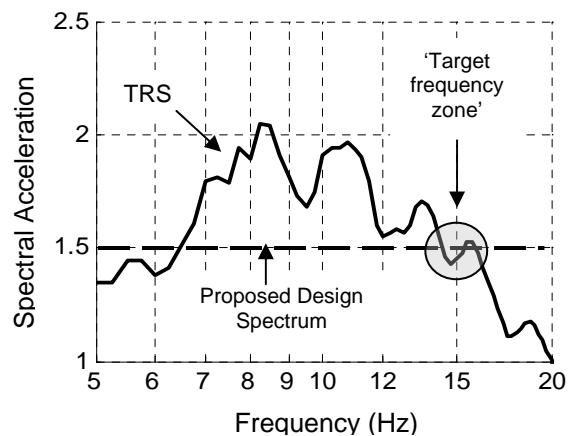
Figure 10b. Test Response Spectrum (TRS) (solid line) in relation to the target maximum acceleration (1.5g)

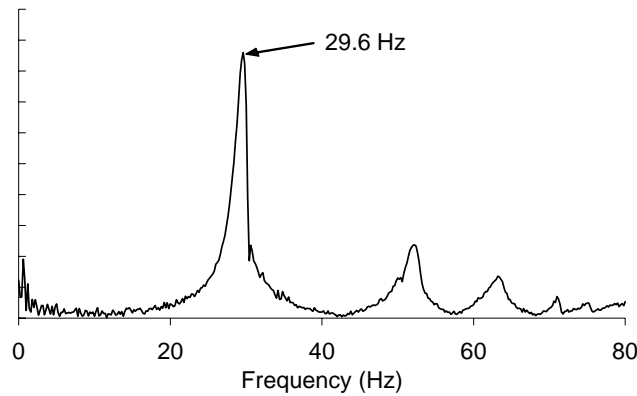
Figure 11. Frequency Response Function (FRF) of specimen 3A from the modal hammer tests.

In order to induce damaging resonance conditions and maintain dynamic similitude between different specimens, the frequency ratio (defined as the ratio of the dominant frequency of the input excitation to the dominant first natural frequency of the structure) must be similar. Clearly it is not possible to alter the natural frequency of each specimen, so scaling of the input spectra is undertaken. This can be done by adjusting the input spectra such that the natural frequency of the specimen lies within the adjusted 'target frequency zone'. By means of modal analysis, the first resonant frequency (natural frequency) of each specimen was identified via the Frequency Response Function (FRF) calculations (Figure 11). The relevant input spectra time scaling factor was then calculated for each specimen (Table 3).

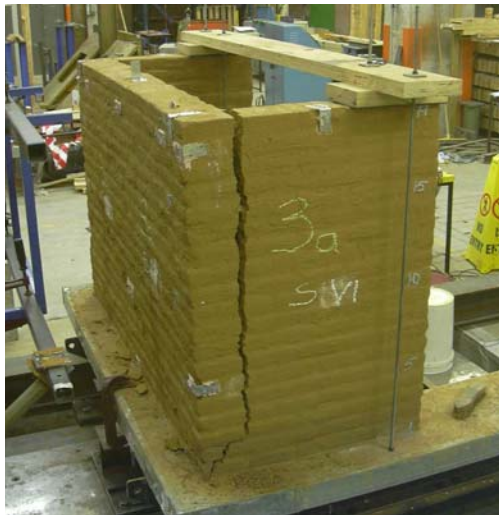
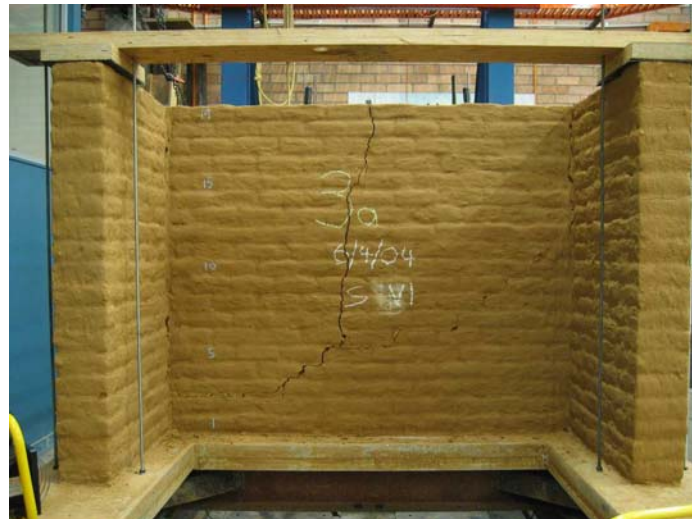
Figure 12a. Specimen 3A after simulation S6

Figure 12b. Specimen 3A after simulation S6

Specimen 3A exhibited distinct and classic failure patterns (Figure 12), indicative of damage to real houses subjected to real earthquakes. A number of factors contributed to the failure of the specimen, including:

- i) Flexure induced in the out-of-plane 'long' wall, causing a splitting-crushing cycle at the mid-span of the wall and the intersection with the orthogonal shear 'wing' walls. (Figure 13 shows the flexural displacement in the 'long' wall prior to formation of the first significant cracks in the specimen.)
- ii) Large relative displacement between the 'flexible' out-of-plane 'long' wall and the stiff in-plane shear 'wing' wall, leading to tearing failure of both the mortar-brick interface and the individual brick units at the corner intersection (vertical corner cracking).
- iii) Overturning of the 'long' wall, which was induced by the lack of connection with the 'wing' walls, a result of the aforementioned vertical corner cracking.

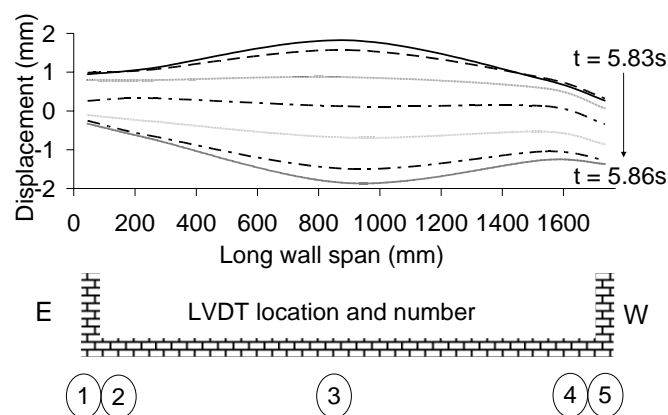
Figure 13. Specimen 3A: flexural displacement of 'long' wall from $t = 5.83s$ to $t = 5.86s$ (prior to initial significant cracking in simulation S6)

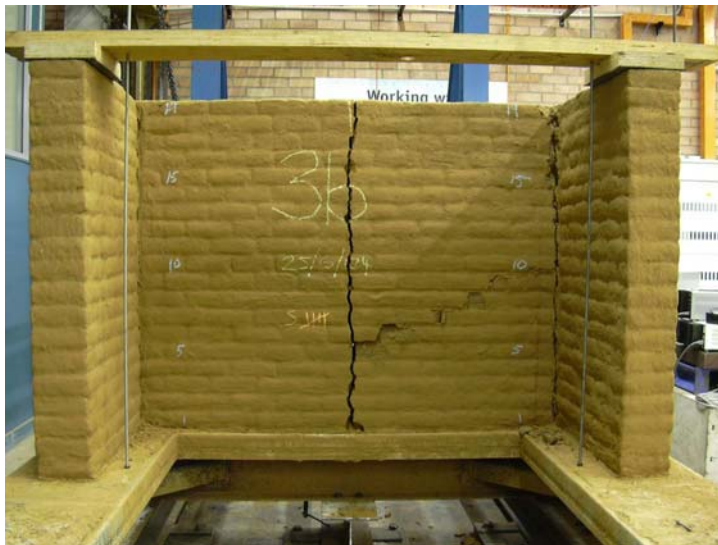
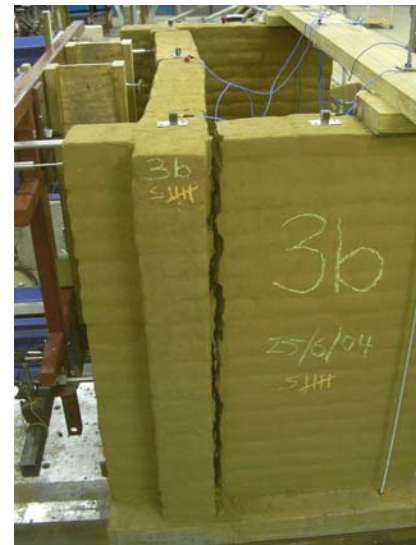
Figure 14a. Specimen 3B after simulation S7.

Figure 14b. Specimen 3B after simulation S7 (NW corner).

Specimen 3B displayed similar failure patterns to Specimen 3A, although the vertical mid-span cracking in Specimen 3B was more pronounced (Figure 14a). A surprising result was the location of the vertical crack (Figure 14b) at the NW intersection of the walls (left side of Figure 14a). It was anticipated that the pilaster would provide some restraint to the overturning moment which induces tearing failure in the wall, and that cracking would initiate on the inside corner, due to the build-up of shear and bending stresses (as seen in the NE corner opposite). This result indicates that the corner pilaster in itself may not be providing the stability desired.

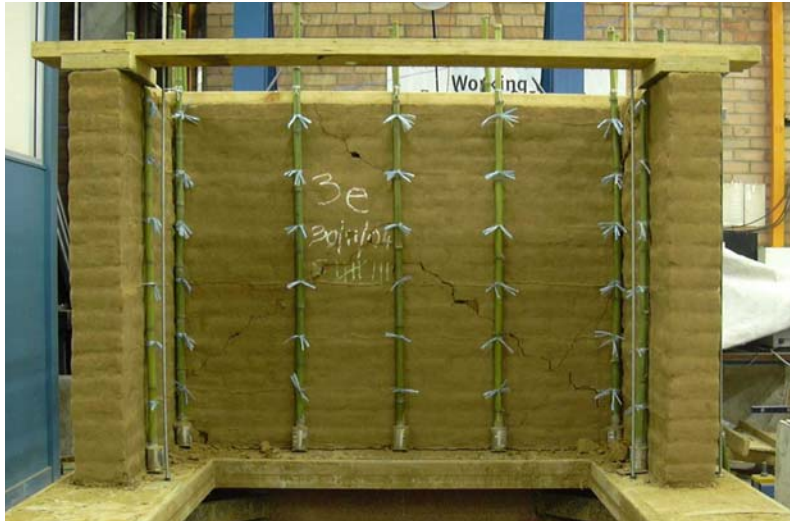
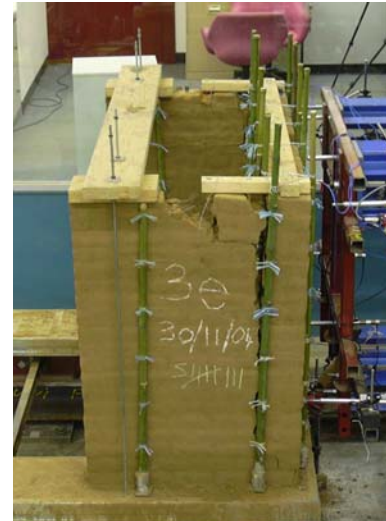
Figure 15a. Specimen 3E after simulation S8

Figure 15b. Specimen 3E after simulation S8

Specimen 3E performed significantly better than the previous specimens, and withstood the forces of a 125% intensity time-scaled simulation without collapse (Figure 15). Collapse of the structure was prevented by the combined contributions of the bamboo, chicken wire mesh and ring beam. This integrated matrix acted to restrain movement, and absorb, dissipate and redistribute energy within the structure. The main factors contributing to damage discussed in Specimen 3A (above) were still evident in the reinforced specimen, however, the impacts were significantly diminished:

- i) Flexure in the out-of-plane 'long' wall was reduced, although vertical mid-span cracking was still caused (obscured by bamboo in Figure 15a), as well as diagonal cracking due to out-of-plane 'bulging' of the 'long' wall.

- ii) The relative displacement between the 'flexible' out-of-plane 'long' wall and the stiff in-plane shear 'wing' wall was reduced, although vertical corner cracking (Figure 15b) was still caused during the high intensity simulations. It is expected that if the ring beam were continuous along the shear 'wing' wall then the development of the vertical corner cracking would have been further delayed.

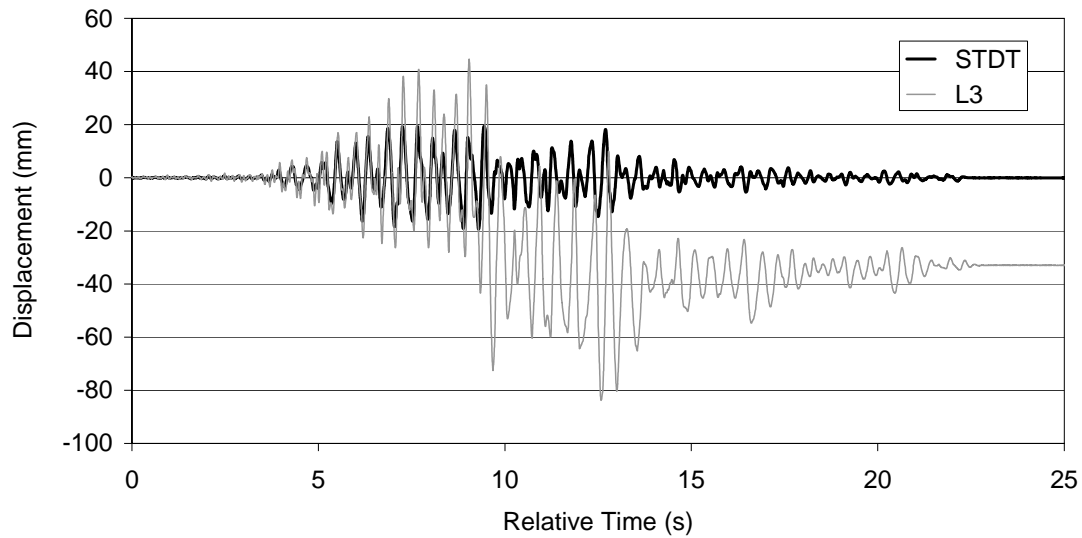
Figure 16. Displacement of shake table (STDT) and top / mid-span of 'long' wall (L3) for specimen 3E during time-scaled simulation S8 (125% intensity)

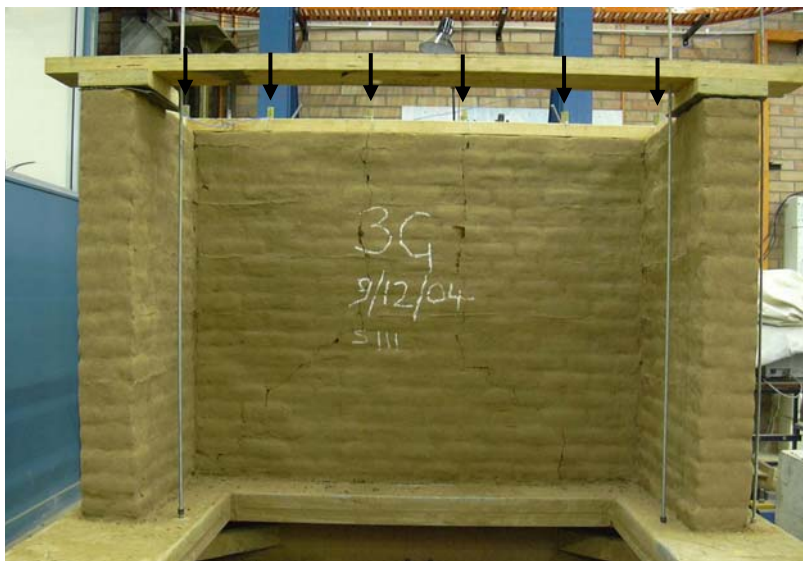
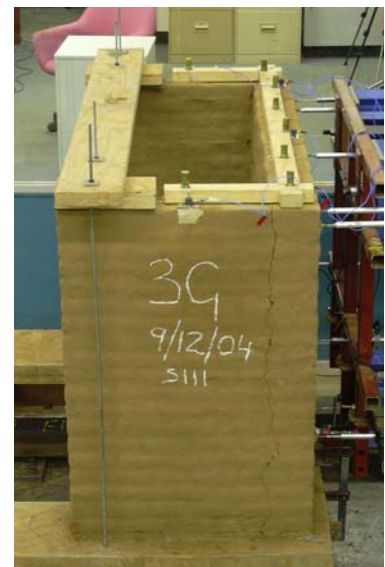
Figure 17a. Specimen 3G after simulation S3 (Arrows indicate the location of internal vertical bamboo)

Figure 17b. Specimen 3G after simulation S3

The behaviour of Specimen 3G was a great surprise: significant cracking occurred after the 200% intensity unscaled (time) simulation (Figure 17). This situation did not occur in any of the other specimens, and suggests significant weaknesses in the structure. The mid-span cracking in the 'long' wall occurred at the location of the internal vertical bamboo, indicating a significant difference in the response of the stiff bricks and the flexible bamboo (this may also account for the lower global stiffness of the structure prior to testing, as shown in Table 3). Results indicate that the internal vertical bamboo has introduced discontinuity to the structure, which has created planes of weakness. The results raise questions about the structural improvement which can be expected by using internal vertical reinforcement, and should be the focus of further testing.

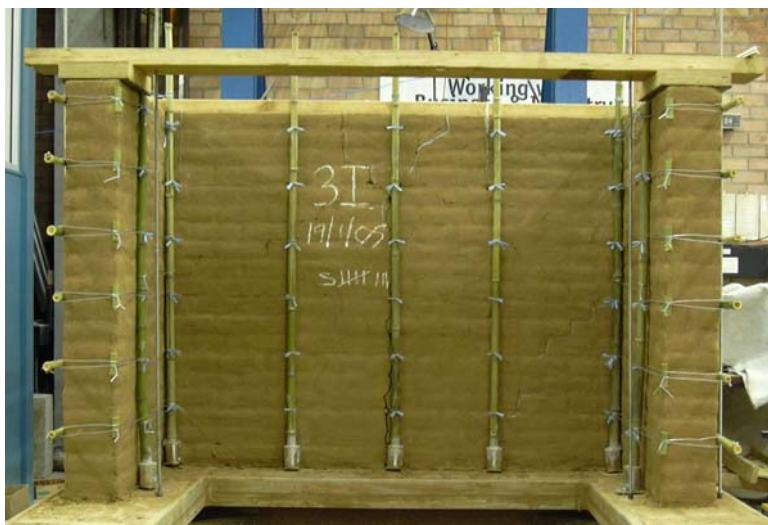
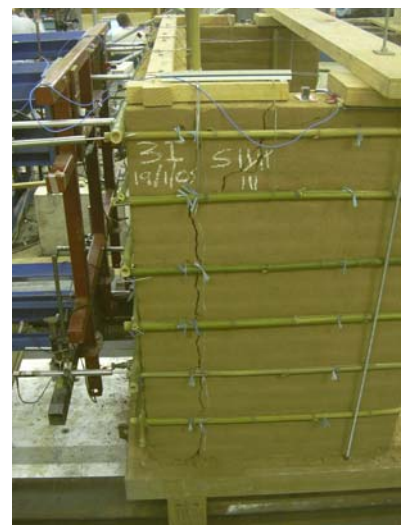
Figure 18a. Specimen 3I after simulation S8

Figure 18b. Specimen 3I after simulation S8

Specimen 3I performed in a similar manner to Specimen 3E, although the initiation and severity of cracking appears to have been delayed and reduced in Specimen 3I. The specimen maintained excellent structural integrity, even during high intensity simulations (100% and 125%). After being subjected to the 125% intensity time-scaled simulation (Figures 18 and 19), the specimen was then subjected to two time-scaled simulations at 75% intensity, followed by four time-scaled simulations at 100% intensity. The results after this series of severe earthquakes are shown in Figures 20 and 21 and reveal the structure to be still safely standing, despite being significantly damaged.

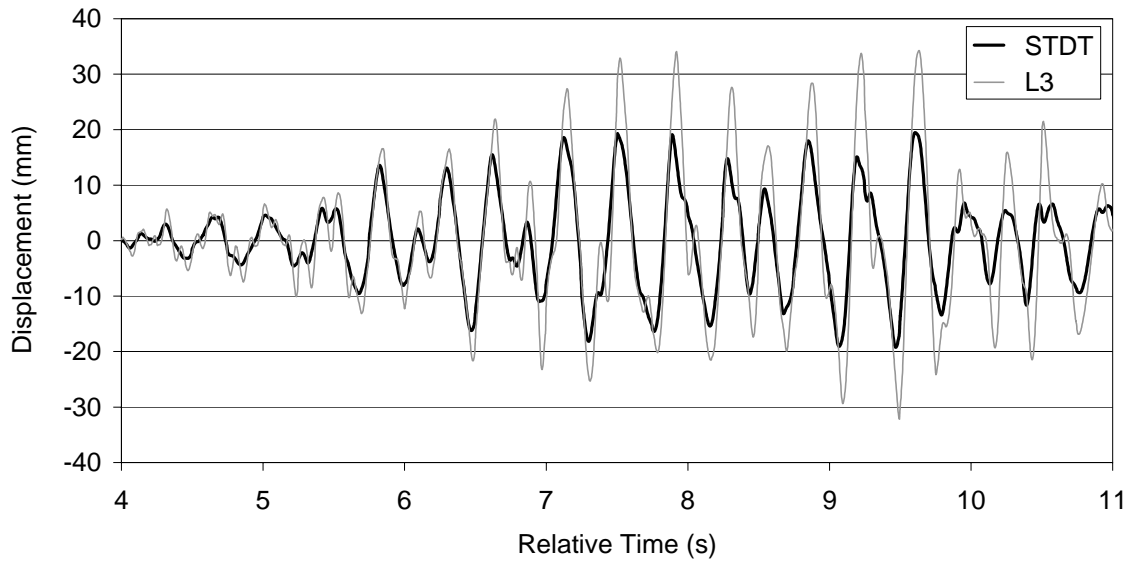
Figure 19. Displacement of shake table (STDT) and top / mid-span of 'long' wall (L3) for specimen 3I during the period of intense shaking leading to cracking during time-scaled simulation S8 (125% intensity)

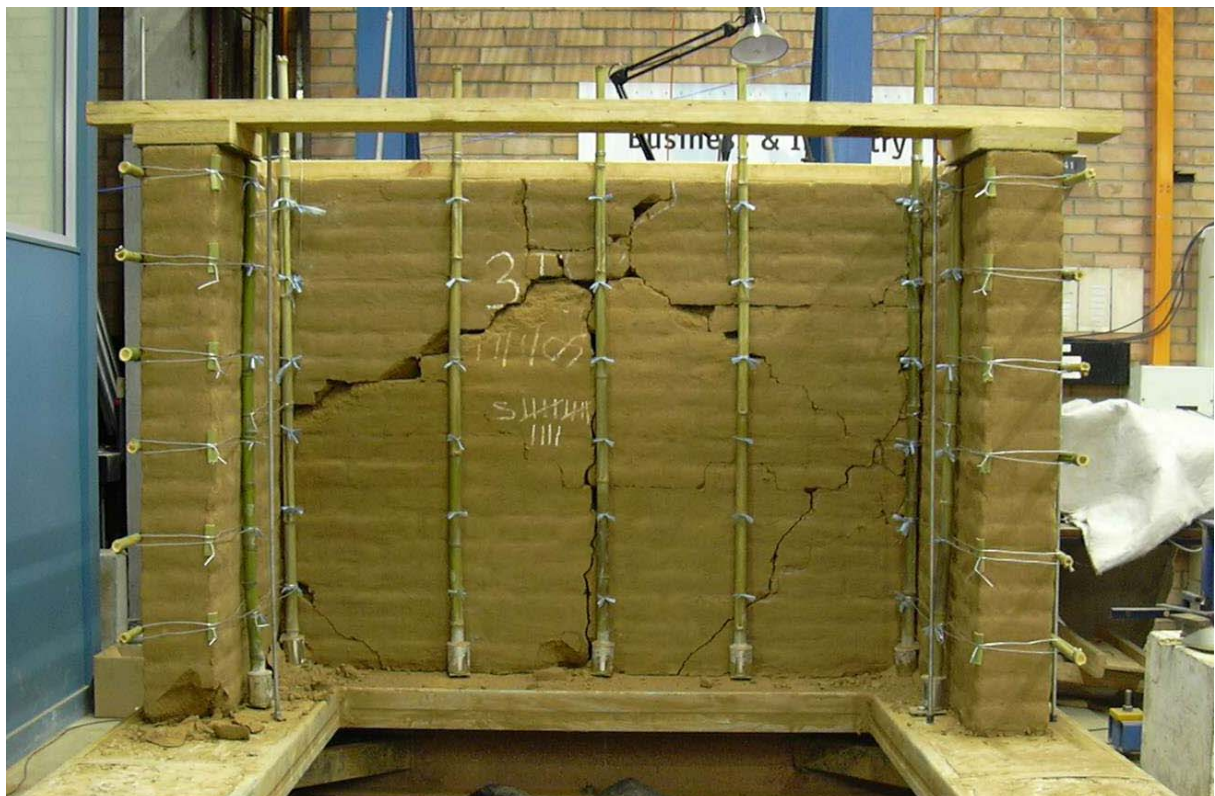
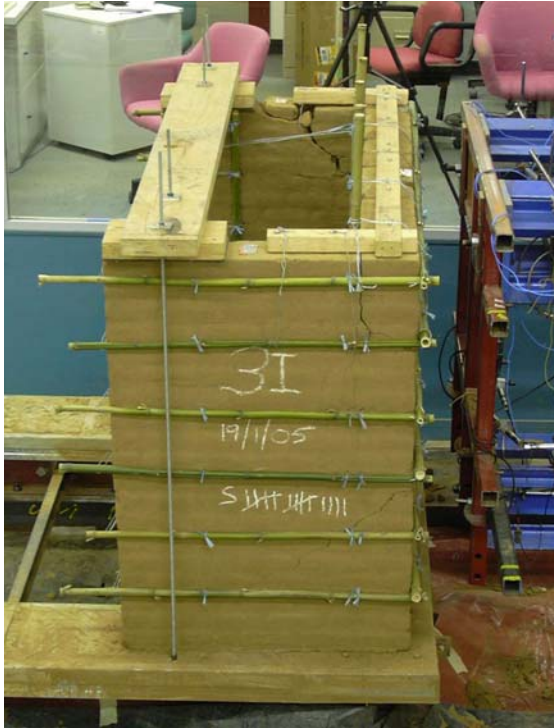
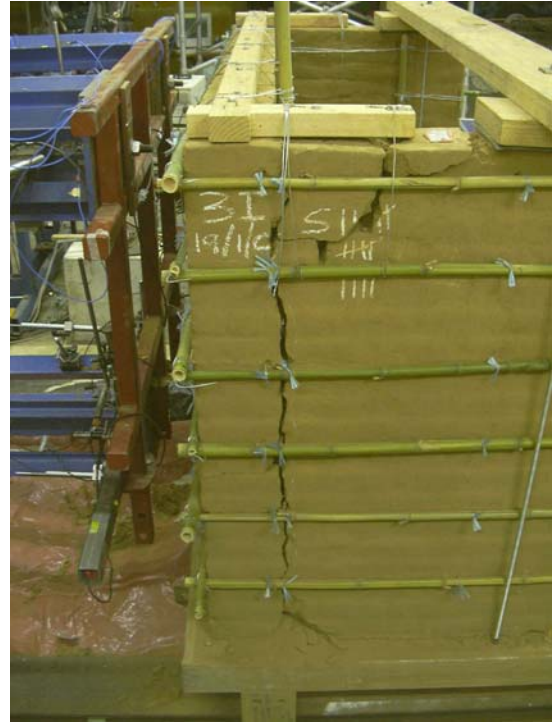
Figure 20. Specimen 3I after simulation S14

Figure 21a. Specimen 3I after simulation S14

Figure 21b. Specimen 3I after simulation S14
