Dominic Dowling
Faculty of Engineering
University of Technology, Sydney
PO Box 123 Broadway NSW 2007
AUSTRALIA
Ph: 0423 957 389
dominic.m.dowling@uts.edu.au
www.eng.uts.edu.au/~ddowling

July 2006

MODEL HOUSE 4A

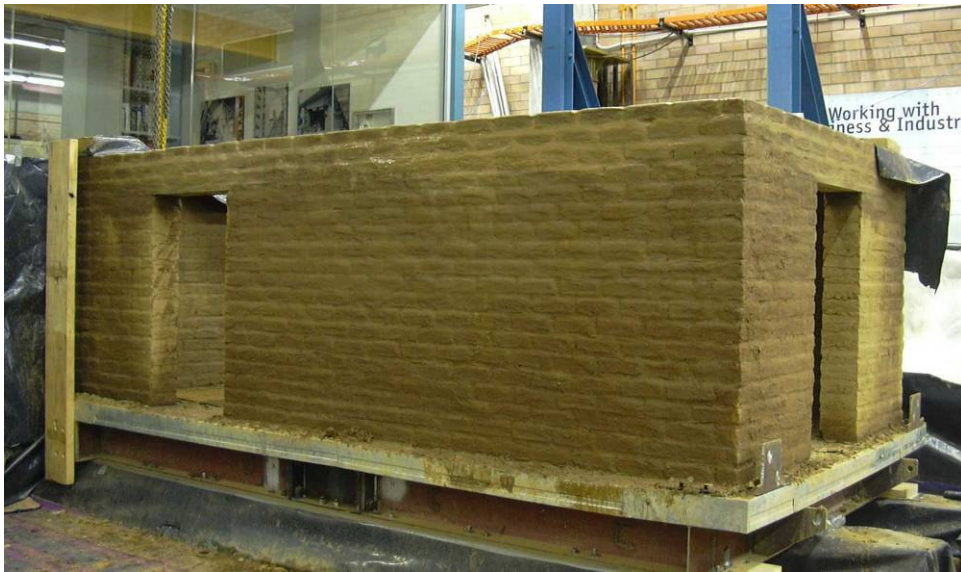
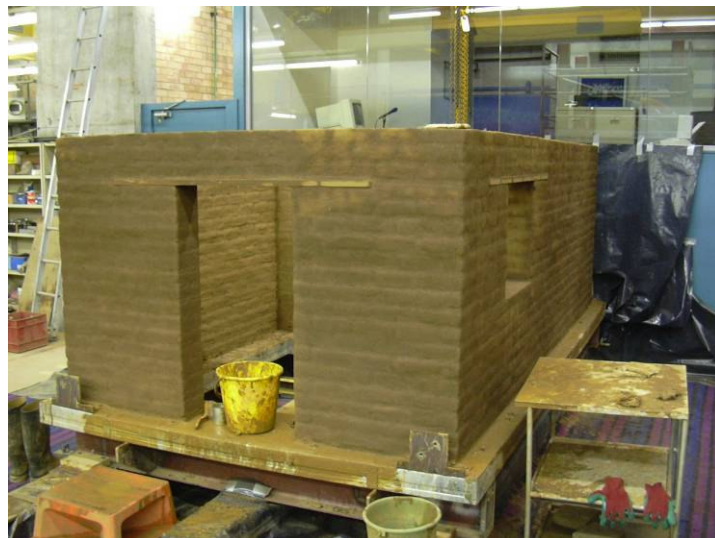
1) Built as a traditional, unreinforced house (walls wetted and rubbed down to create smooth and attractive appearance)

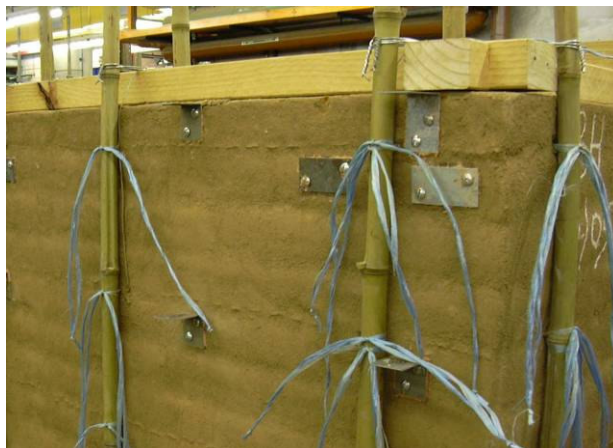
(The steel plates in the photo were for instrumentation during testing and are not part of the proposed system)

c) Tie on vertical bamboo poles (inside and outside building)
